January 18, 2018

Re: Coal Combustion Residual (CCR) Landfill Annual (2017) Inspection
Clear Springs Ranch
Fountain, Colorado
Terracon Project No. 23155030

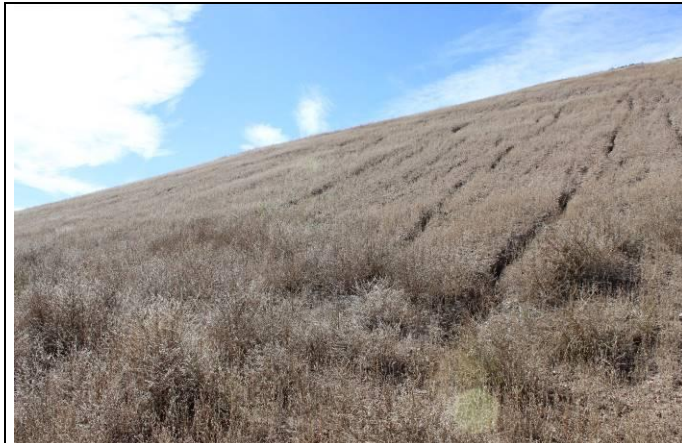
Photo #7 Facing Southwest

During our initial site visit, we observed a slight to moderate amount of erosion rills and gullies along all slopes. Most erosion features were less than about 6 inches deep. However, several erosion features were up to about 10 inches below the south facing slope surface at the southeast corner of the landfill.

- The upslope roadway berm had one, approximate 1-foot wide erosion channel along the south face near the southeast corner of the landfill (See Photos #11).
- The east facing slope at the southeast corner of the landfill (see Photos #7 to #10) has rills and erosion features up to about 10 inches deep.
- Burrowing animal damage to top berm (see Photos #39 and #40). This could develop into a breach if not repaired

We recommended to UTILITIES representatives that slopes with erosion features (gullies) greater than about 3 to 6 inches deep be filled and re-graded. We understand the grading activities are typically accomplished by tracking a bulldozer up and down the slopes. In addition, we recommended the soil berms adjacent to roadway and at the crest of the slope be repaired as necessary for continuity.
