January 11, 2019

Re: Coal Combustion Residual (CCR) Landfill Annual (2018) Inspection
Clear Springs Ranch
Fountain, Colorado
Terracon Project No. 23155030

CCR LANDFILL ANNUAL INSPECTION
CLEAR SPRINGS RANCH
FOUNTAIN, COLORADO

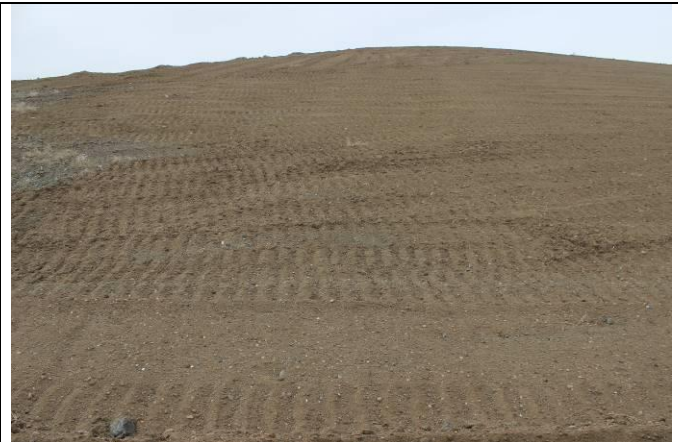
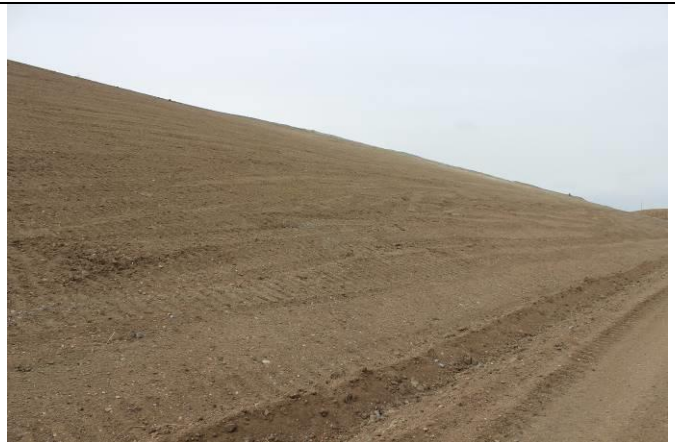
Photo #48 Facing West		Photo #49 Facing Northwest

During our subsequent site visit on December 28, 2018, the three areas described in the Observations Section of this report had been repaired and were noted in Photos #48 through #59. The slopes with the erosion channels and rills were subsequently graded to re-establish a continuous soil cap. The berm breach in the area of Photo 19 noted previously, was also repaired by establishing a secondary continuous berm (Photo #53). In addition to the areas noted for recommended regrading, UTILITIES also graded a majority of the north facing slope (Photos # 55 through 59) for a relatively even soil cap.

We recommended to UTILITIES representatives that slopes with erosion features (gullies) greater than about 3 to 6 inches deep be filled and re-graded. We understand the grading activities are typically accomplished by tracking a bulldozer up and down the slopes. In addition, we recommended the soil berms adjacent to roadway and at the crest of the slope be repaired as necessary for continuity.
