RE: Coal Combustion Residual (CCR) Landfill Annual (2024) Inspection
 Clear Spring Ranch
 Fountain, Colorado
 Terracon Project No. 23155030

CCR Landfill Annual Inspection, 2024

Clear Spring Ranch | Fountain, Colorado

January 14, 2025 | Terracon Project No. 23155030

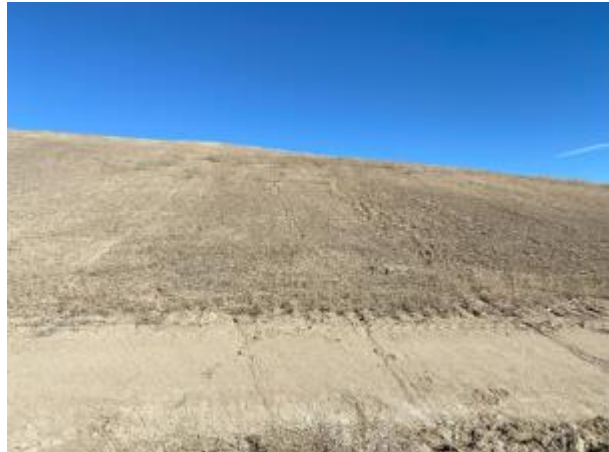
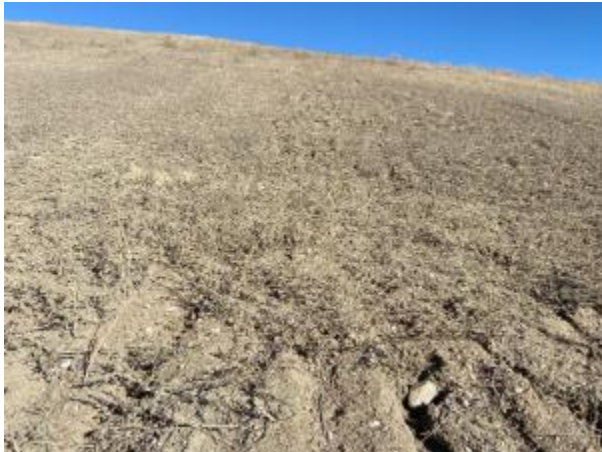
In our subsequent inspection performed on December 3, 2024, we observed erosion rills and gullies located at the south and east facing slope surfaces in the southeast and eastern area of the fly ash portion of the landfill (see Photo Nos. 31 to 32 and 34 to 41 in the attached Photo Location Diagram and Photography Log). Most of the erosion features were about 6 to 10 inches deep. In addition, the localized separation of the primary containment berm at the southern portion of the site had been repaired, however, a second separation of the primary containment berm at the base of the slope along the northern perimeter road was observed (see Photo Nos. 42 to 43 and 45 to 49 in the attached Photo Location Diagram and Photography Log).

- Two areas along the south facing slope developed localized areas with rills extending up to 10 inches through the 12-inch soil cap. These areas should be regraded to establish a uniform 12-inch soil cap.
- Two areas along the south and north facing slope developed localized separations within the primary containment berm. These areas should be repaired to re-establish the separation berms to approximately 12 to 18 inches in height, without separations.
- The two culverts near Photo Nos. 21 to 23 were partially clogged with sediment to about a quarter of their diameter from previous storm events. We note that the culverts will have a reduced flow capacity recommend the culverts be cleaned to remove the sediment.

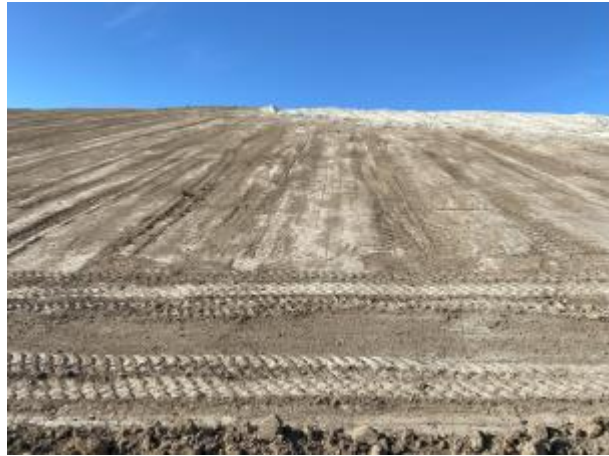
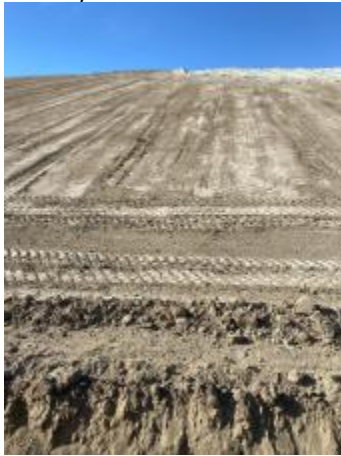
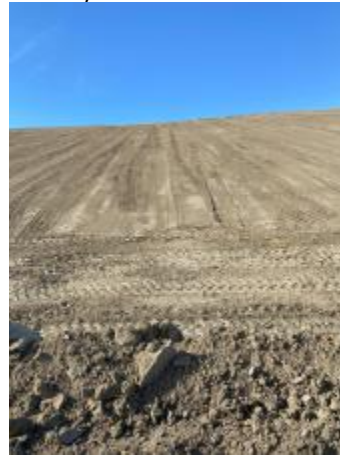
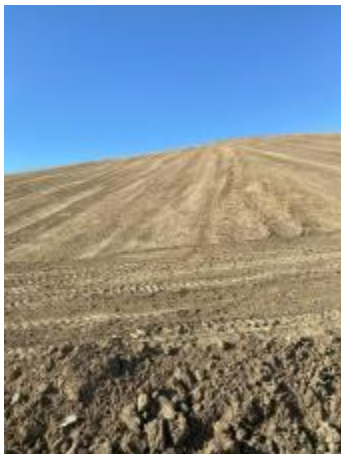
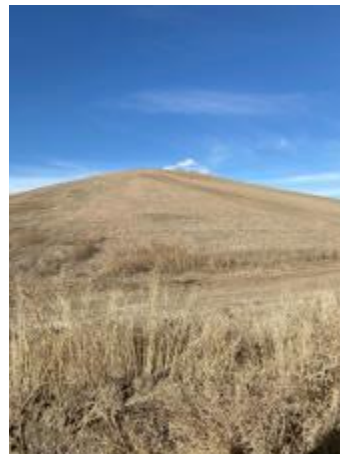
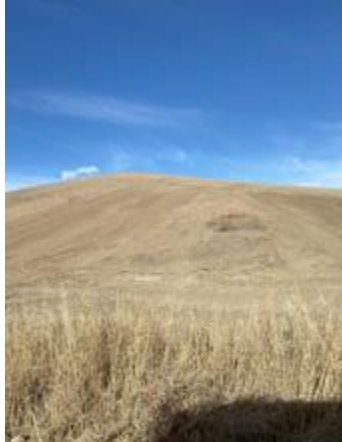
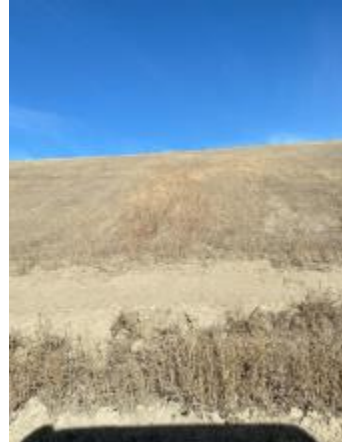
On December 17, 2024, Terracon completed a third site visit and observed portions of the southern and eastern slope had been regraded to fill gullies (see Photo Nos. 51 to 57 in the attached Photo Location Diagram and Photography Log). In addition, the previously mentioned primary berm separations had also been repaired, as shown in Photo Nos. 58 to 62 in the attached Photo Location Diagram and Photography Log. The cleaning of the two culverts on the north side of the landfill was still in process at the time this report was prepared.
