RE: Coal Combustion Residual (CCR) Landfill Annual (2024) Inspection
 Clear Spring Ranch
 Fountain, Colorado
 Terracon Project No. 23155030

CCR Landfill Annual Inspection, 2024

Clear Spring Ranch | Fountain, Colorado

January 14, 2025 | Terracon Project No. 23155030

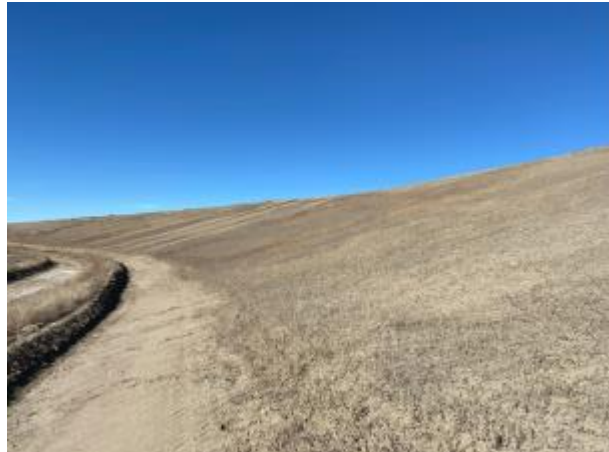
Photo No. 33, 12.03.2024 Observations

In our subsequent inspection performed on December 3, 2024, we observed erosion rills and gullies located at the south and east facing slope surfaces in the southeast and eastern area of the fly ash portion of the landfill (see Photo Nos. 31 to 32 and 34 to 41 in the attached Photo Location Diagram and Photography Log). Most of the erosion features were about 6 to 10 inches deep. In addition, the localized separation of the primary containment berm at the southern portion of the site had been repaired, however, a second separation of the primary containment berm at the base of the slope along the northern perimeter road was observed (see Photo Nos. 42 to 43 and 45 to 49 in the attached Photo Location Diagram and Photography Log).

- Two areas along the south facing slope developed localized areas with rills extending up to 10 inches through the 12-inch soil cap. These areas should be regraded to establish a uniform 12-inch soil cap.
- Two areas along the south and north facing slope developed localized separations within the primary containment berm. These areas should be repaired to re-establish the separation berms to approximately 12 to 18 inches in height, without separations.
- The two culverts near Photo Nos. 21 to 23 were partially clogged with sediment to about a quarter of their diameter from previous storm events. We note that the culverts will have a reduced flow capacity recommend the culverts be cleaned to remove the sediment.
