Re: Coal Combustion Residual (CCR) Landfill Annual (2020) Inspection
Clear Springs Ranch
Fountain, Colorado
Terracon Project No. 23155030

PHOTOGRAPH LOCATION DIAGRAM
CCR LANDFILL ANNUAL INSPECTION CLEAR SPRINGS RANCH FOUNTAIN, COLORADO

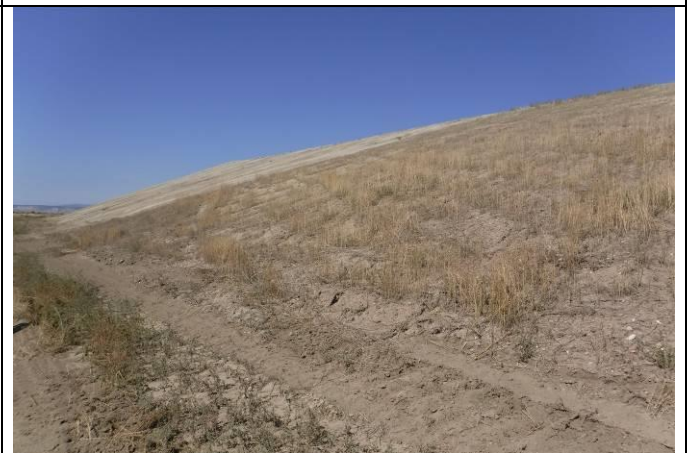
<p>Photo #9 Facing North</p>		<p>Photo #10 Facing Northwest</p>

- Exposed CCRs at a cut bank on top of the landfill near its southeast portion (no photos)
- Some erosion rills were becoming relatively deeply incised near the middle area of the south facing slope (Photo #9)
- Some erosion rills were becoming relatively deeply incised near the middle area of the west facing slope (Photo #17)
- Some erosion Rills were becoming relatively deeply incised at the northeast corner of the landfill (Photos #34, #35, and #36)

We recommended to UTILITIES representatives that slopes with erosion features (rills and gullies) greater than about 3 to 6 inches deep be filled and re-graded. We also recommended regrading to establish a minimum 1-foot thick soil cap in areas where CCRs are exposed.
